# C.A. Home Inspections

## **Property Inspection Report**

1234 Main St, Sample, TX Inspection prepared for: Bob Smith Real Estate Agent: Top Agent - Best Agency

Date of Inspection: 3/14/2019 Time: 10:00 AM Age of Home: 2008 Size: 2,975 sqft Weather: Clear and 75°

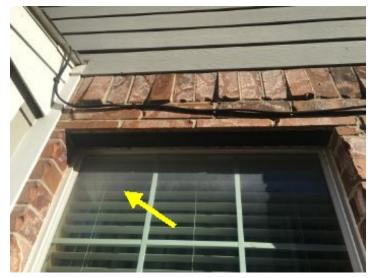
- Windows are made of vinyl Comments:
- Thermal pane window seals have failed. Moisture and or discoloration is present between window glass panes. This has resulted in condensation or a fog like film to develop between the panes of glass. The thermal pane windows no longer function as designed when they loose their seal and repair or replacement is needed.
- Exterior sealant (caulking) improvements are needed between the exterior wall cladding and the window frames. Sealants applied between window frames and exterior walls prevent moisture intrusion.

Upstairs window has lost thermal seal
